## SERVICE BULLETIN

AUTOMATIC AIR ENTRY WINDOW INTO THE BALANCE JAR (AIRBOX) FOR ENGINES ROTAX 80HP TURBO CHARGED.

*April 02, 2008*

**SB-Ibis-003**

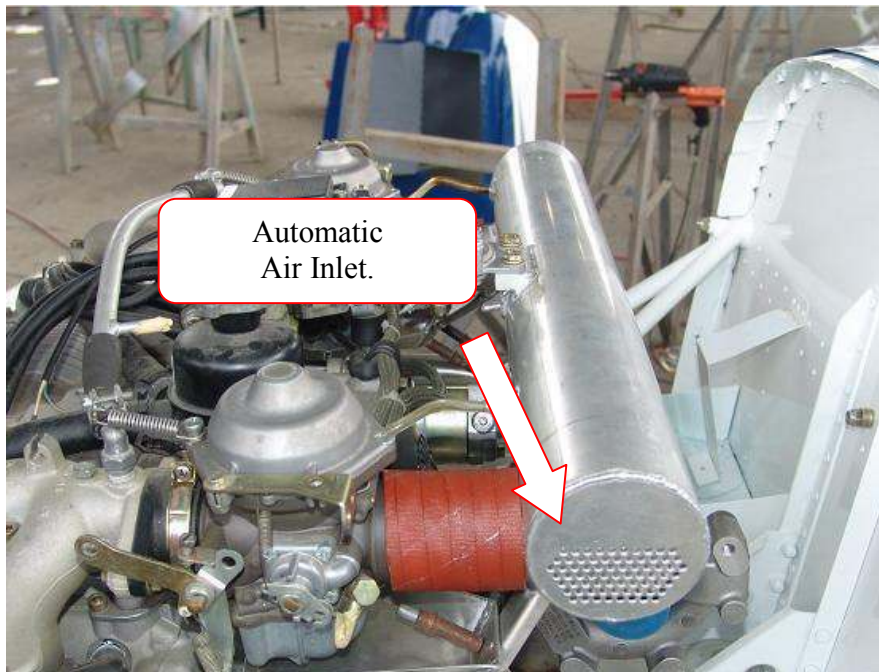
1. In some cases It has been observed that the automatic entry window in the Balance Jar (Airbox) when there is a fault in the turbo system the window does not open in order for the system to work normally aspirating, leading to a flaw in the engine system due to the low volume of air entering.
2. At sea level it shows that the turbo system puts 2 inches more of pressure- thus preventing the engine to work normally aspirating even if the vernier cable is completely out (this creates an unnecessary wear of the engine) since the normal operation of the engine should be maximum up to 30 inches in the Manifold.

**INSTRUCTION.** In the balance Jar (Airbox), where the automatic air inlet is located a modification should be made, this system should be abolished and be replaced by a manual system operated by a cable from inside the cabin.

You must remove the lid where the automatic air inlet is located, in order to realize a new one with a modification, and keeping the same diameter of the balance jar of the Turbo system (Airbox), the modification consists in making an air inlet in the center of the new lid that is activated by a manual cable from inside the cabin. As shown in the illustration.

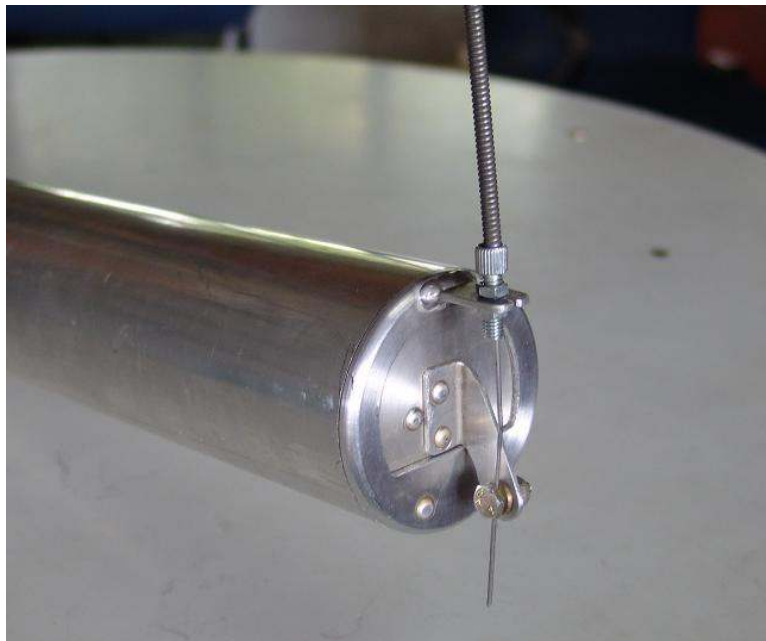
*"Closed" air inlet. Setting to operate the Turbo system Turbo*

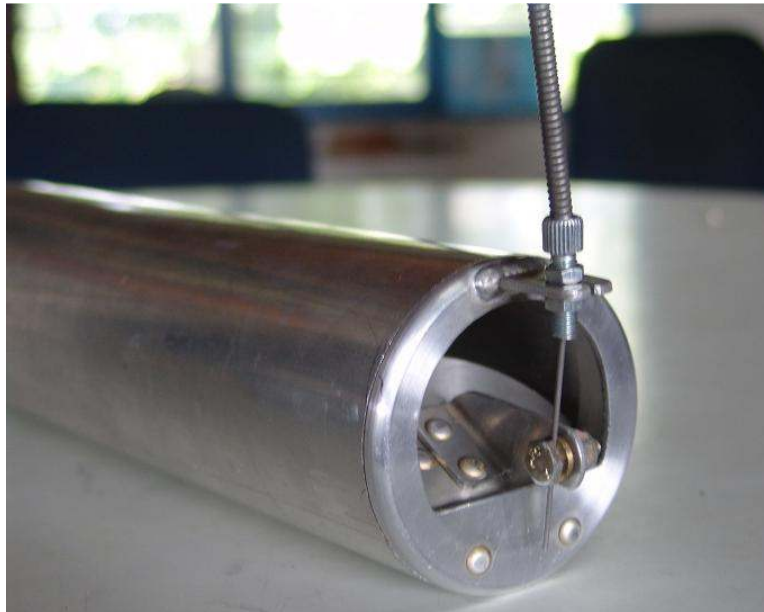
*“Open” Air inlet Setting Normally Aspirated*

Once welded the manual air inlet to the balance jar of the Turbo system (Airbox) and the cable placed at the air inlet and adapted to the interior of the cabin, it is ready for operation.
