SERVICE BULLETIN

RIB SUPPORT MODIFICATION FOR FIBER GLASS STABILIZER -
ELEVATOR TIP.

October 02, 2008

SB-Ibis-006

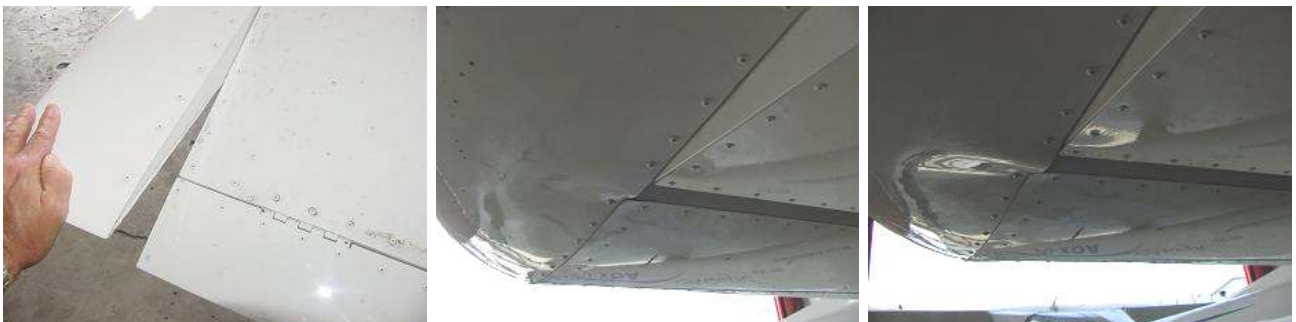
INSTRUCTION. When applying pressure on the fiber tip, this deforms, therefore the tie should be strengthened, completing the rib that is located inside the fiber holding the stabilizer.
