## SERVICE BULLETIN

REGULAR INSPECTIONS OF THE SCREWS HOLDING YOKES SYSTEM LOCATED AT THE TOP CENTER OF THE FIRE WALL.

**SB-Ibis-001**

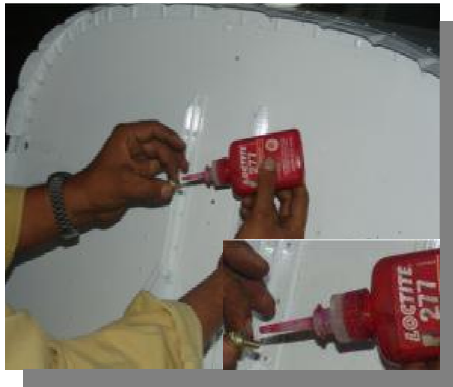
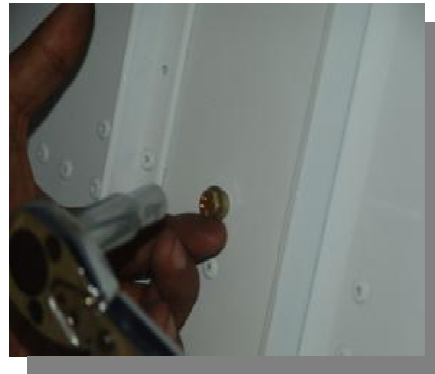
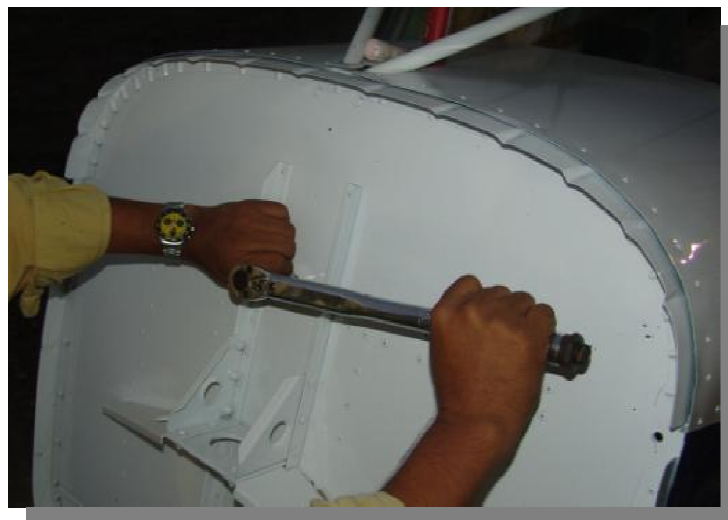
**INSTRUCTION.** Remove screw and hub AN 3 – 4A located in the top center of the fire wall holding yokes system

*NOTE:* To be sure check the attached picture.

Thoroughly clean the surfaces of the screw and the threaded end of the tube where it is fastened, (removing grease, or other pollutants). Apply a drop of LOCTITE 277 (Thread locker). Immediately adjust screw AN 3 - 4A with its respective hub with a 5 Foot / Pound torque to the yokes system. Check that the aileron controls are smooth enough to operate.

Allow it to dry approximately 1 hr after the modification before realizing the next flight

Check regularly the adjustment of this screw
