## SERVICE BULLETIN

MODIFICATION IN THE VENT LINE OF THE RESERVOIR TANK OF THE FUEL SYSTEM.

**SB-Ibis-002**

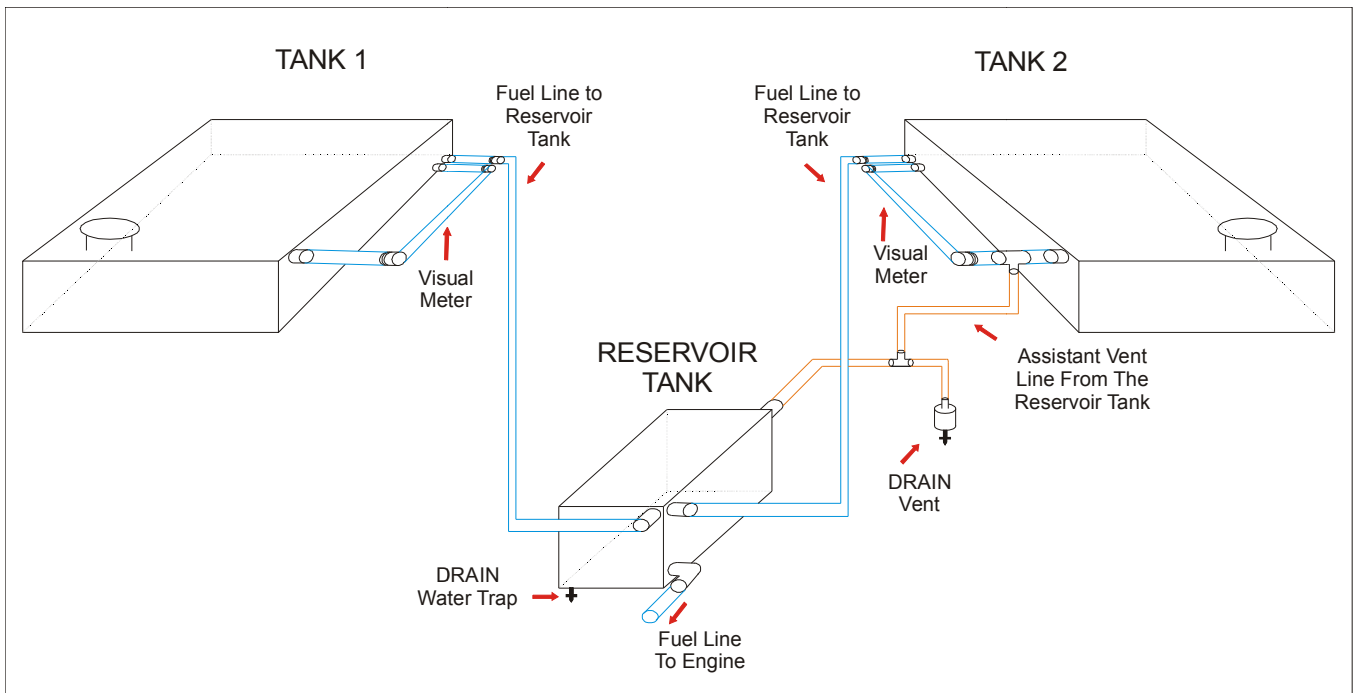
**NOTE:** To verify more clearly check out the attached drawing.

**INSTRUCTIONS.** from the gas line to drain the gas the reservoir tank is removed with a "T" line that is taken to the highest part of one of the main tanks which is the superior line of the visual meter, this coupling is done by another "T" at this point, the hose couplings are adjusted properly with their respective clamp.
